# CULTURAL HERITAGE EVALUATION REPORT

## Deloro Mine Site Township of Marmora and Lake County of Hastings, Ontario

**Report Number:** 11-1126-0037-4000-R06

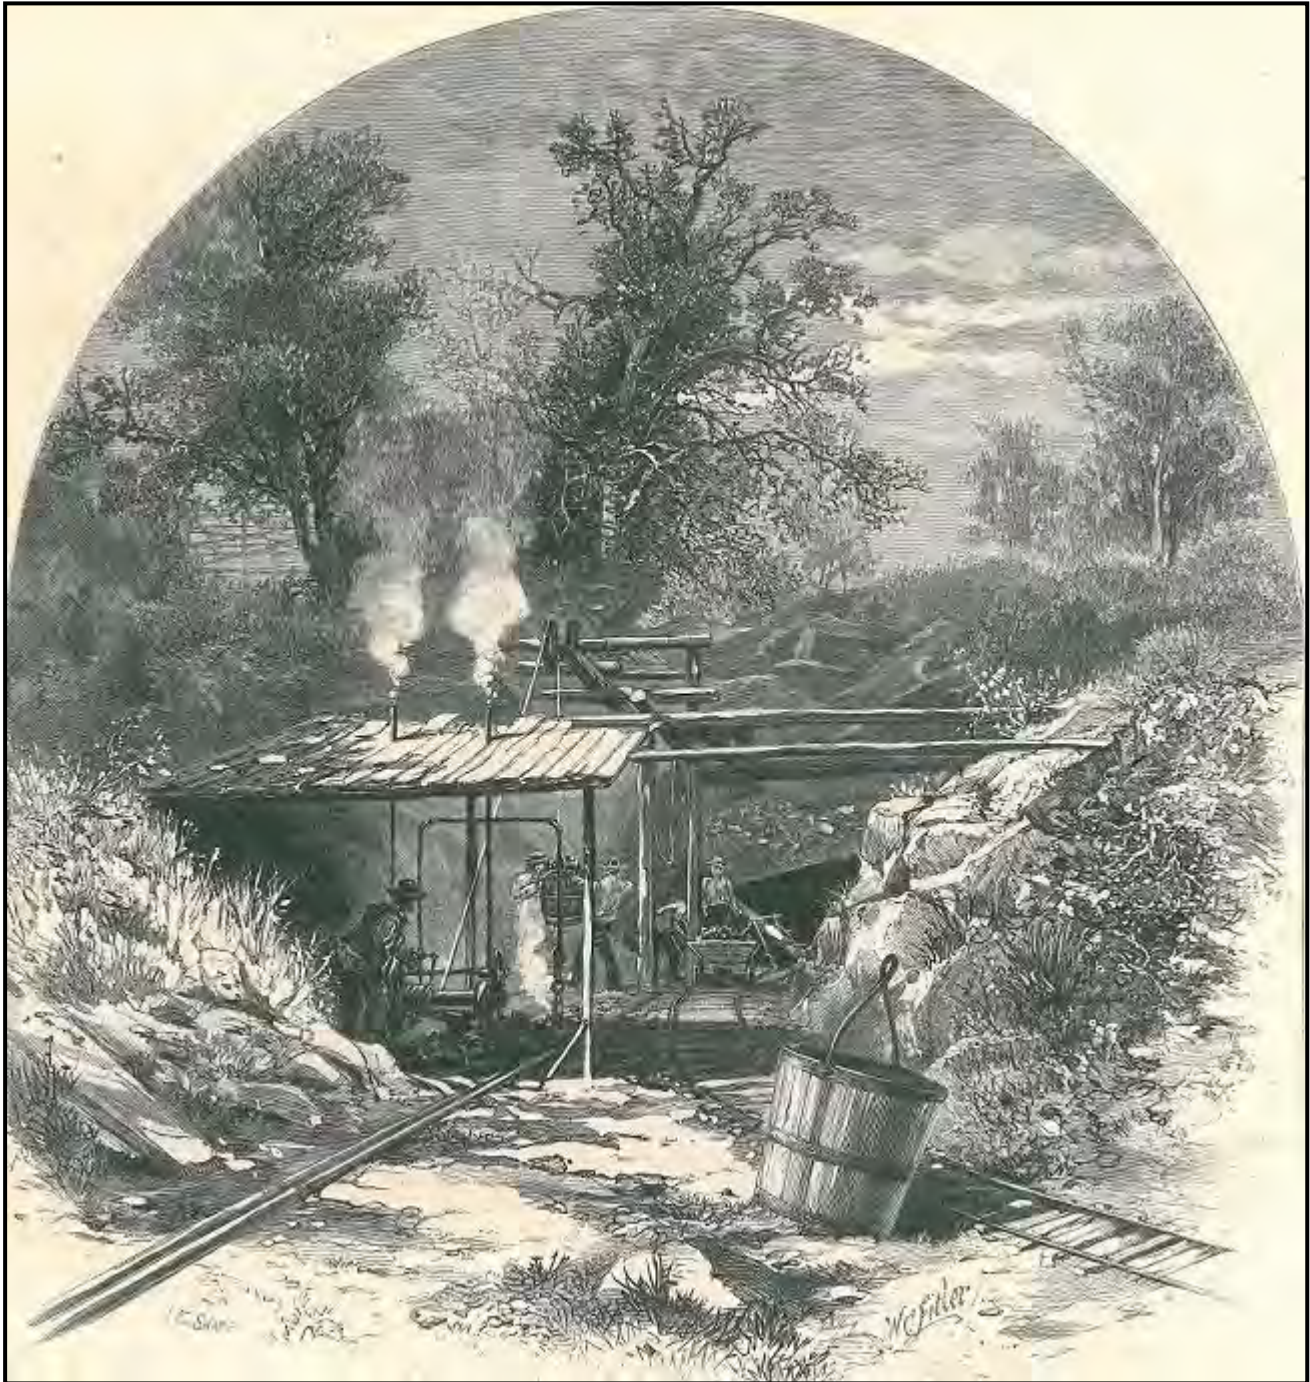
Plate 3: Iron mining at Marmora c.1880 illustrating an adit. Steam engine hoist over mine shaft; two iron pipes on left for compressed air or steam for drills, tramway track on right with bucket for ore. Picturesque Canada

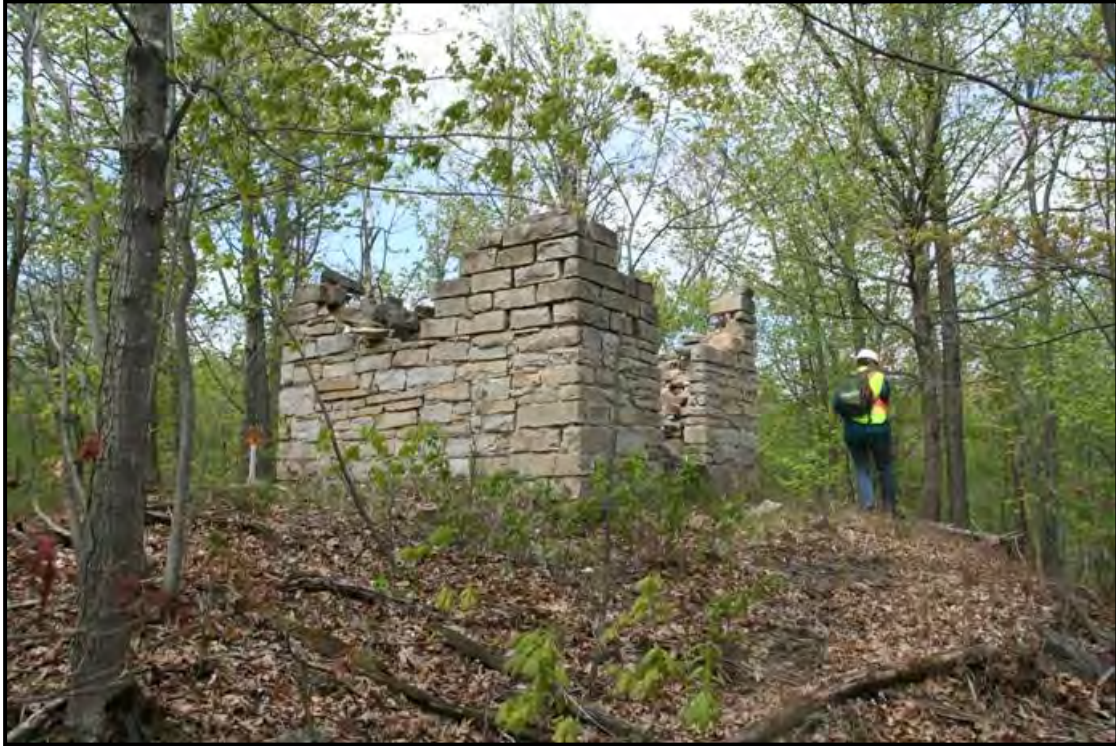
*Plate 6: Powder House with entrance door facing former Gatling Mine*

The Commonwealth report describes the powder magazine as in "fair to good condition". The change between 1987 and 2011 illustrates the continual deterioration of the structure.

The ERA Conservation Report concluded that the masonry structure is in poor condition. It has deteriorated largely as a result of the removal of the lead roof more than 20 years earlier.

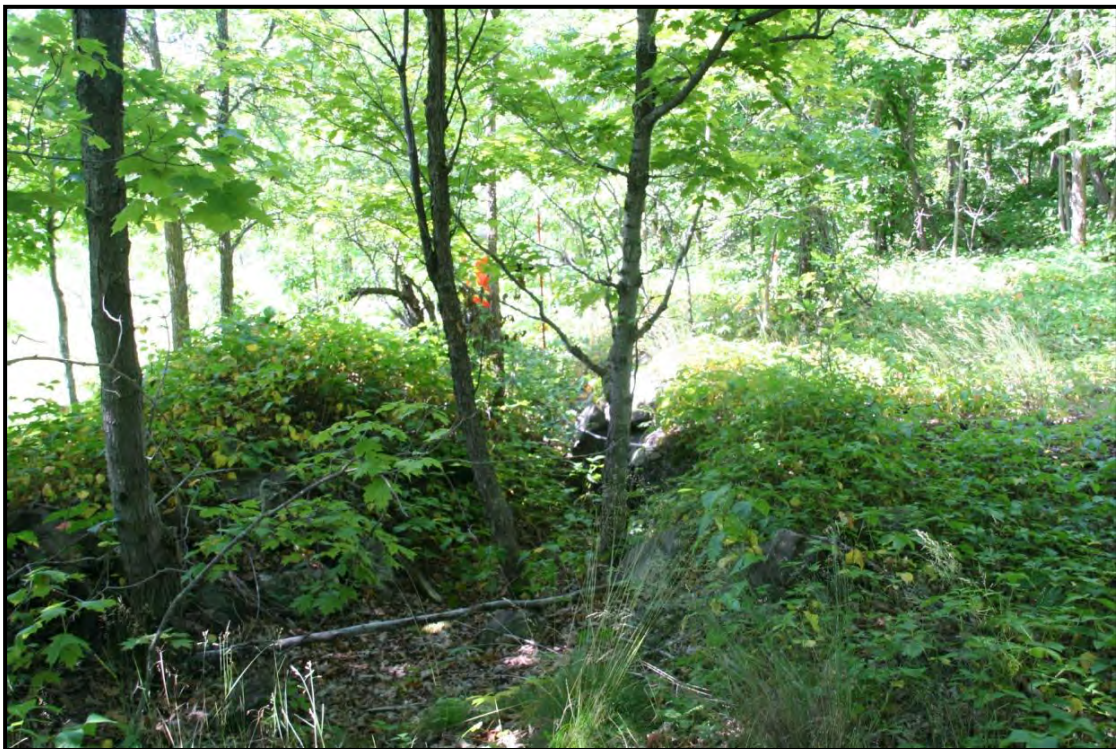
*Plate 7: Powder House Vein located by the two trees in the vein in the foreground*
