PROJECT			
CULTURAL HERITAGE EVALUATION REPORT DELOORO MINE SITE TOWNSHIP OF MARMORA AND LAKE HASTING COUNTY, ONTARIO			
TITLE			
PROPOSED VILLAGE OF DELOORO, 1918			
PROJECT No. 11-1126-0037		FILE No. 1111260037-4000-R06001	
CADD	DCH	Apr. 20/12	SCALE NTS REV.
CHECK			FIGURE 19

**CULTURAL HERITAGE EVALUATION REPORT
DELORO MINE SITE, COUNTY OF HASTINGS**

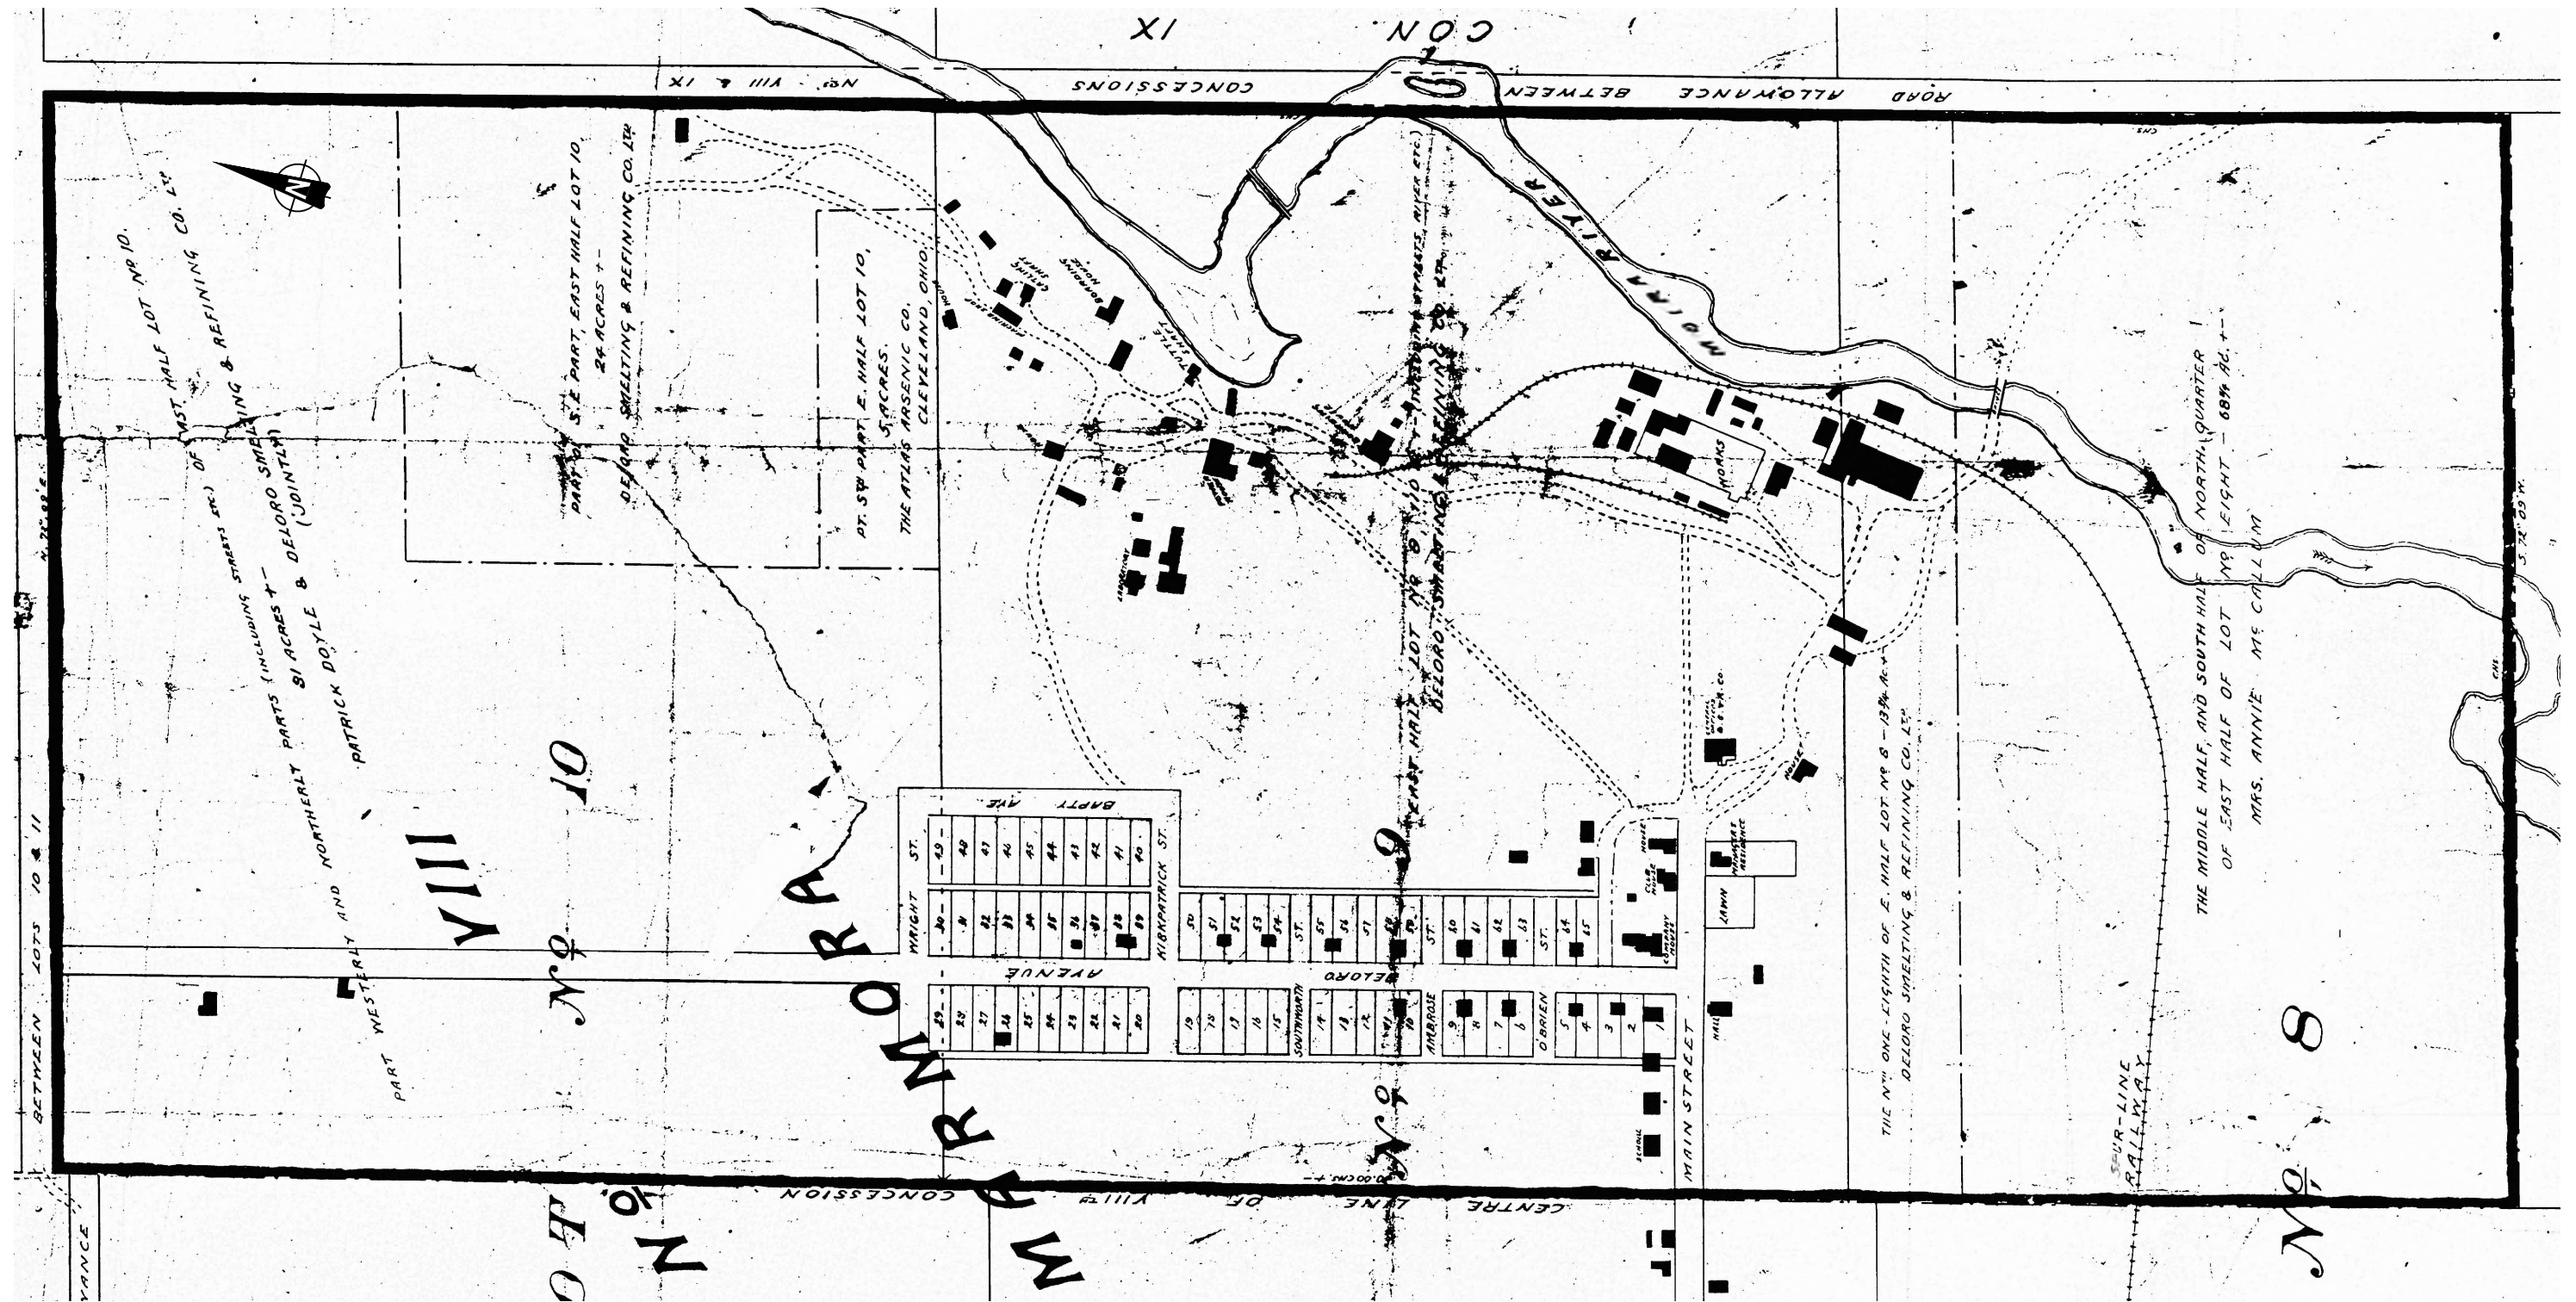
PLAN

TO SHEW

PROPOSED CORPORATE BOUNDS
- of the -
VILLAGE OF DELOORO,

- LOCATED ON -
EAST HALVES OF LOTS 8, 9 & 10.

IN THE
EIGHTH CONCESSION,
T.P. MARMORA,
CO. HASTINGS,
ONT.

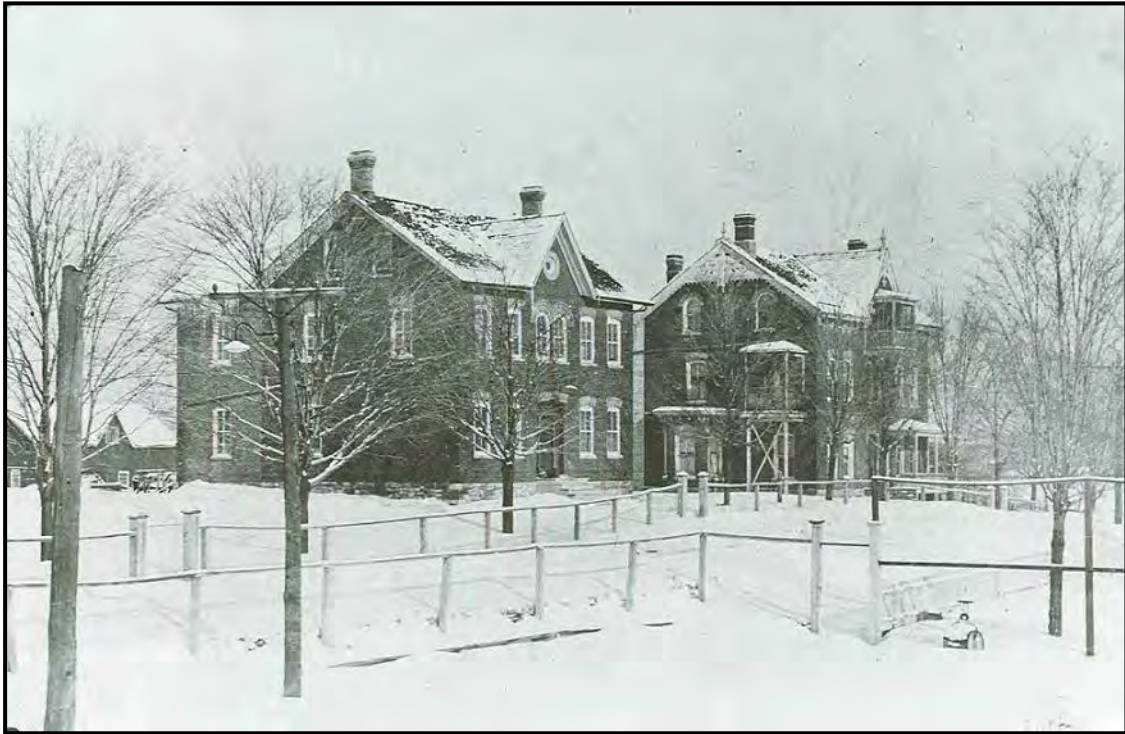
Plate 68: Canada Consolidated office building and Director's Residence, built c1882; later, under the charge of Canada Goldfields, it was used as a residence for staff. Photo c1900.

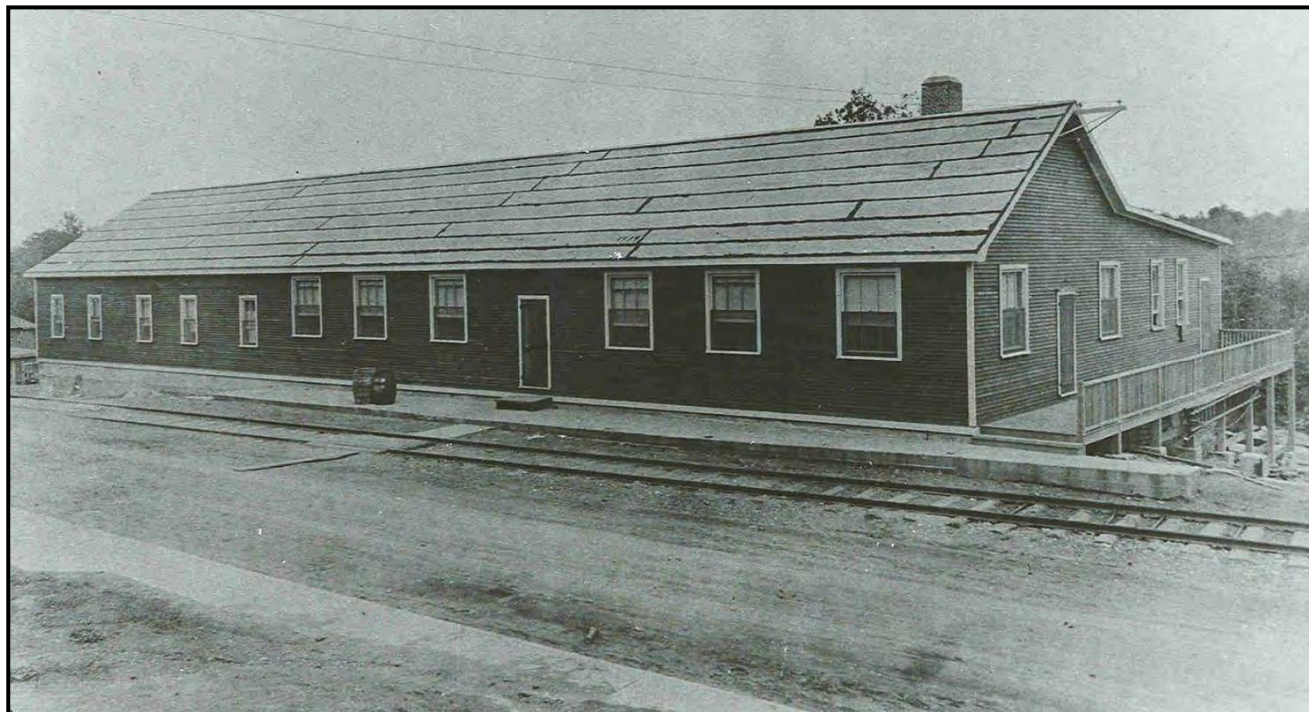
Plate 70: The new Hub sometime after 1919. The track in the foreground led to the primary treatment building ore yard.

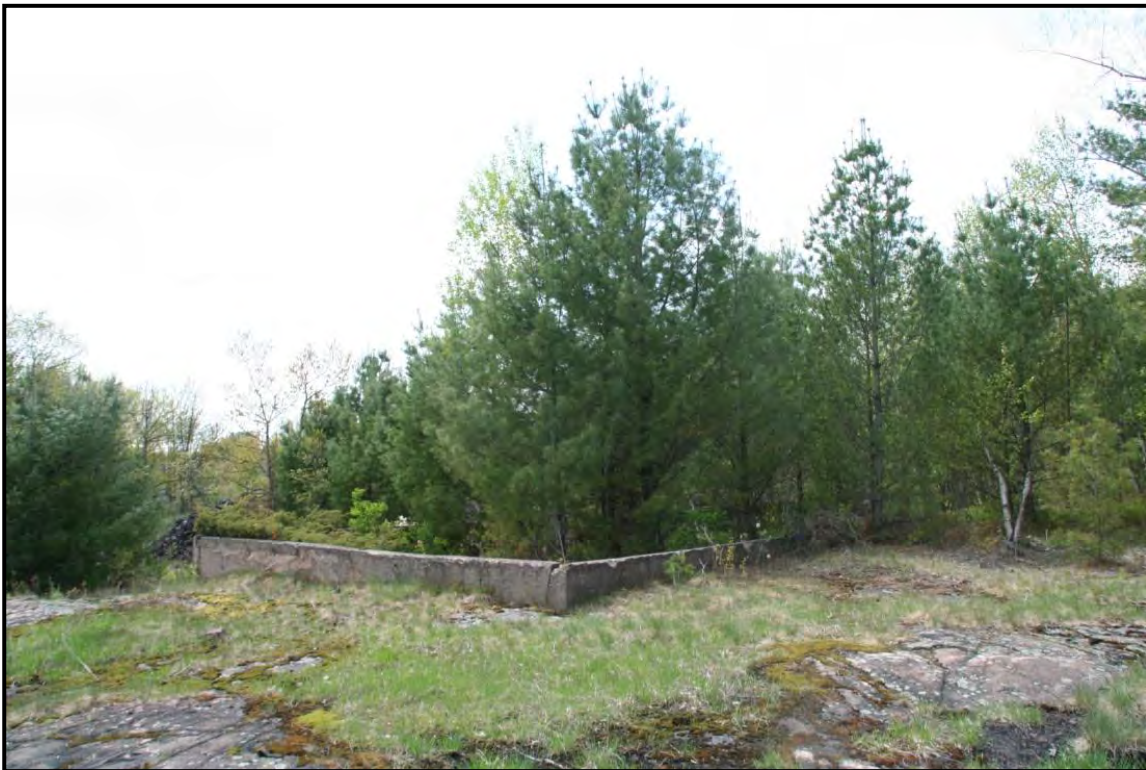
Plate 73: Bunkhouse ruin, 2011.

- Ruins of the “Hub” and Kitchen.
- Concrete footings of three buildings used as Bunkhouses.
- Offsite presence of the former village of Deloro.

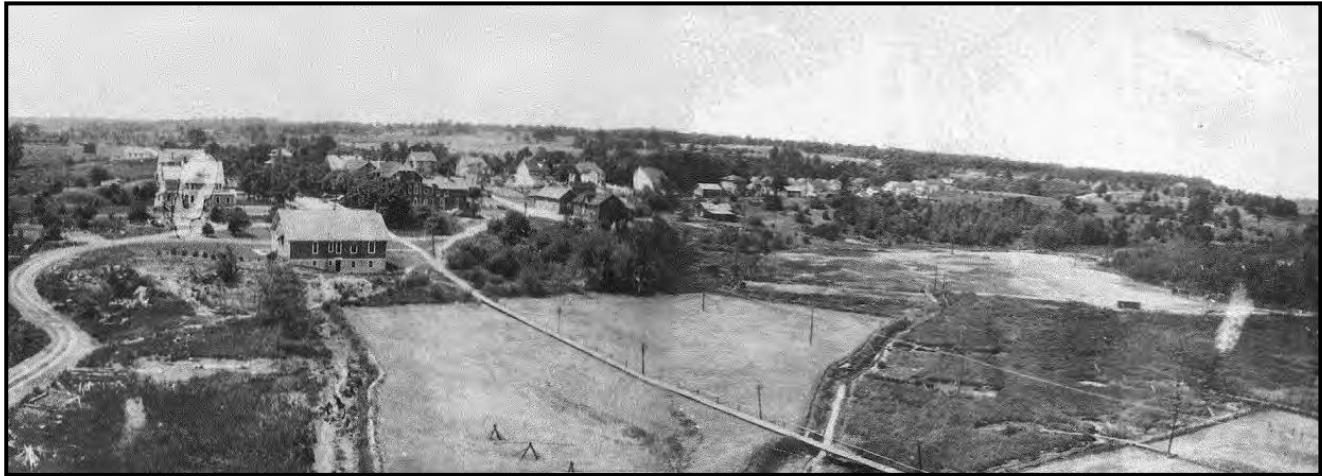
Plate 74: View from water tower of Deloro Village showing boardwalk over the wet land to the refinery complex.

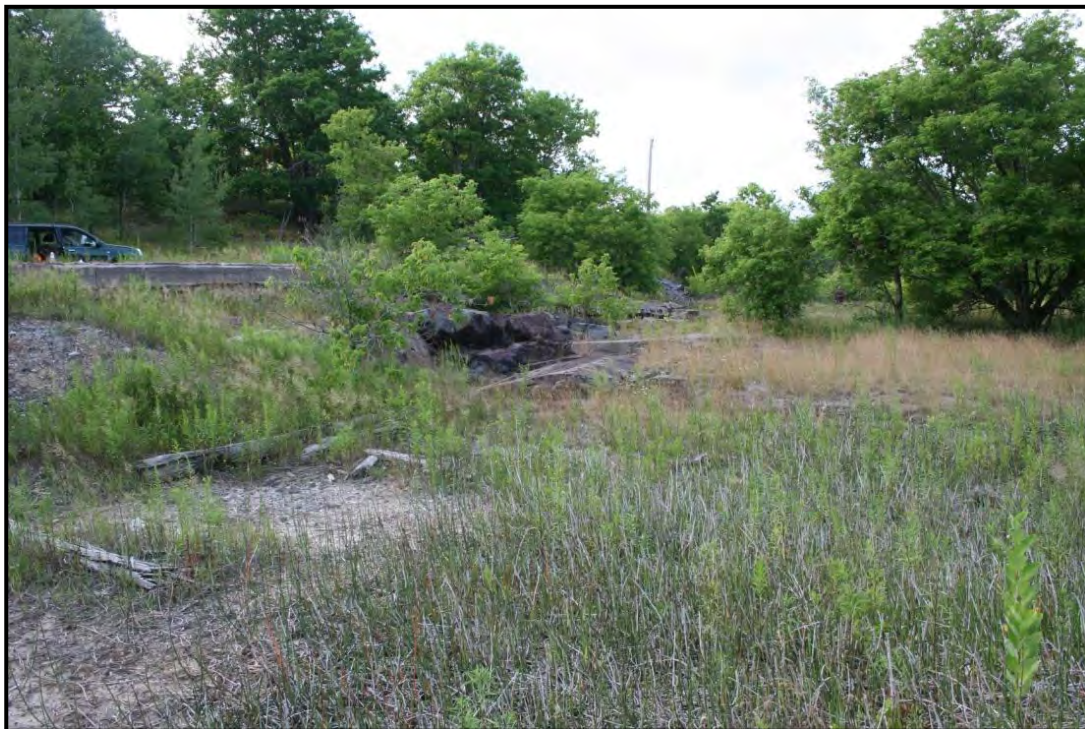
Plate 75: Looking across the site of the Hub showing concrete footings. The rail line/service road is in the left where the car is sitting.

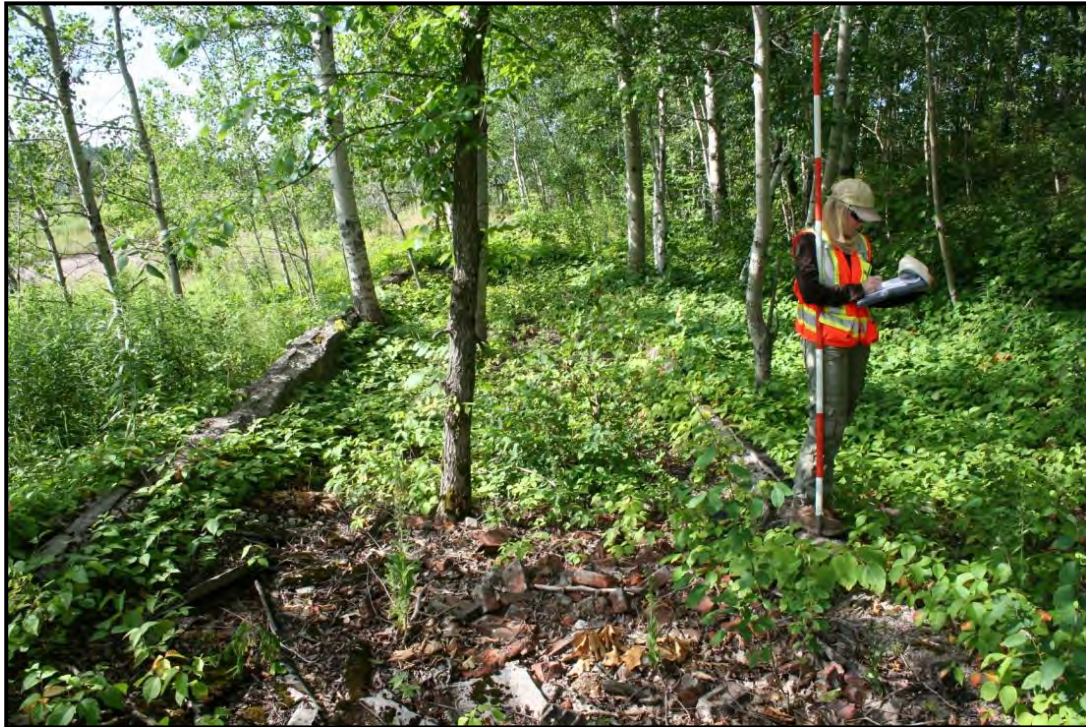
Plate 76: Ruins of former Kitchen located near the Hub.

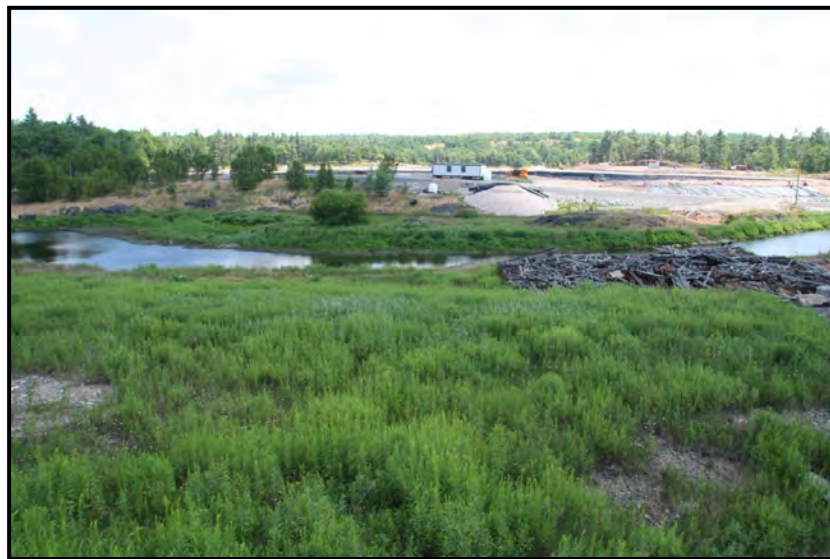
Plate 77: Looking across the Moira River to the Tailings Pond remediation, 2011.

In 2010-11 remediation work focused on the east bank of the Moira River. A comprehensive engineered cover was put in place on the tailings area (tailings pond). (Plate 77). Additional work was also undertaken at the former Cook and Pearce Mine Shafts. Construction of the final engineered cover for the tailings area began in 2011. The final remediation of the Tailings Area is anticipated to be completed in 2012.
